Manhole Inspection Summary

Manhole # S33KK_044MH

Insp Date: 11/30/06 11:52 AM

Location Address: **1901 HOWARD ST**

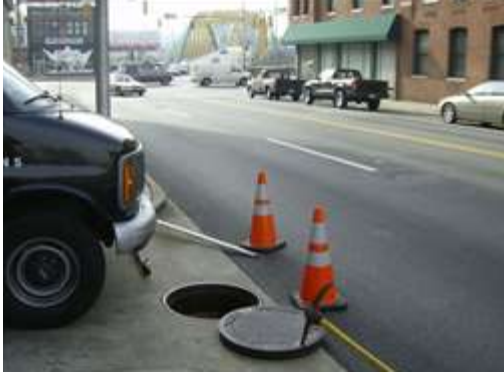
Location View

Frame leaks. Adjustment, Corbel and Barrel infiltration. Evidence of surcharge - Bench debris. Channel debris.
